The Burnside Village Tree – A Case Study of Construction and Tree Protection

Marcus Lodge
Arborman Tree Solutions

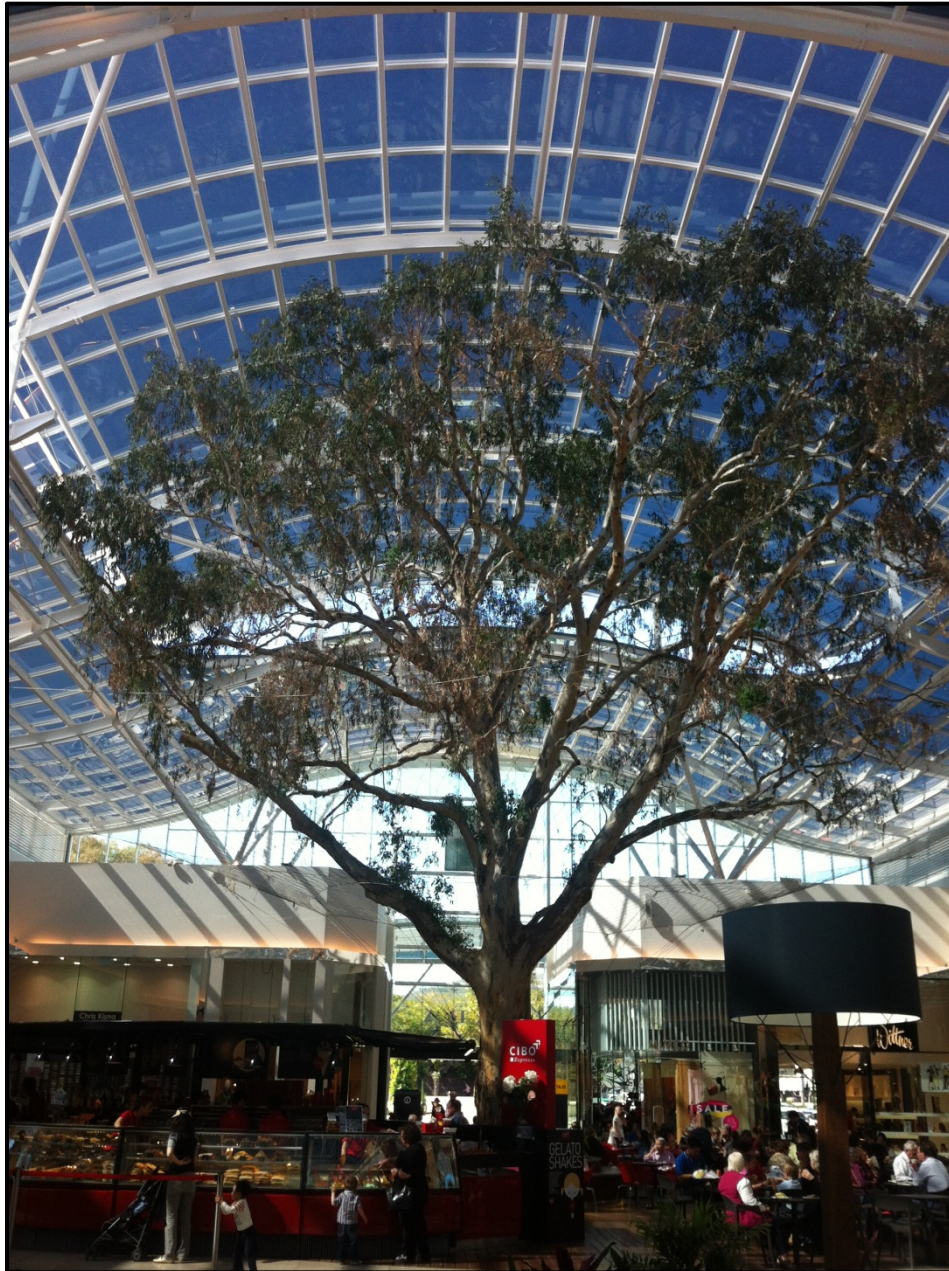
1. The light levels were at the lowest point for photosynthesis to occur and given River Red Gum is a relatively high light user it appears leaves that were unable to be productive were/are being shed.
2. The humidity is so low, dry air, in the crown that for the majority of the day the leaf stomata were effectively closed; this further limits both the tree's ability to take up water and therefore to photosynthesise.
3. There is increased insect and fungal activity on the leaves which is likely to be related to the low humidity.
4. Water whilst available is not being taken up due to the lack of photosynthetic activity and the low humidity causing the stomata to close.

Obvious thinning and dead leaf retention particularly in the lower canopy.

- Modification of the air conditioning system to prevent dry, heated or cooled, air being directed onto the tree.
- Installation of a misting system to increase the humidity in the crown to the point where stomata activity is normalised.
- Installation of a full spectrum lighting system to increase the usable light available for photosynthesis.
- Crown management to remove sections that are not going to recover and maximise the potential for the remaining branches to improve their foliage cover.
- Ongoing monitoring and treatment of soil moisture and nutrient levels to maintain the tree's requirements.
