# A GEOTECHNICAL ENGINEER'S APPROACH TOWARDS TREES.

D A Cameron

School of Natural & Built Environments, University Of South Australia, Mawson Lakes, SA

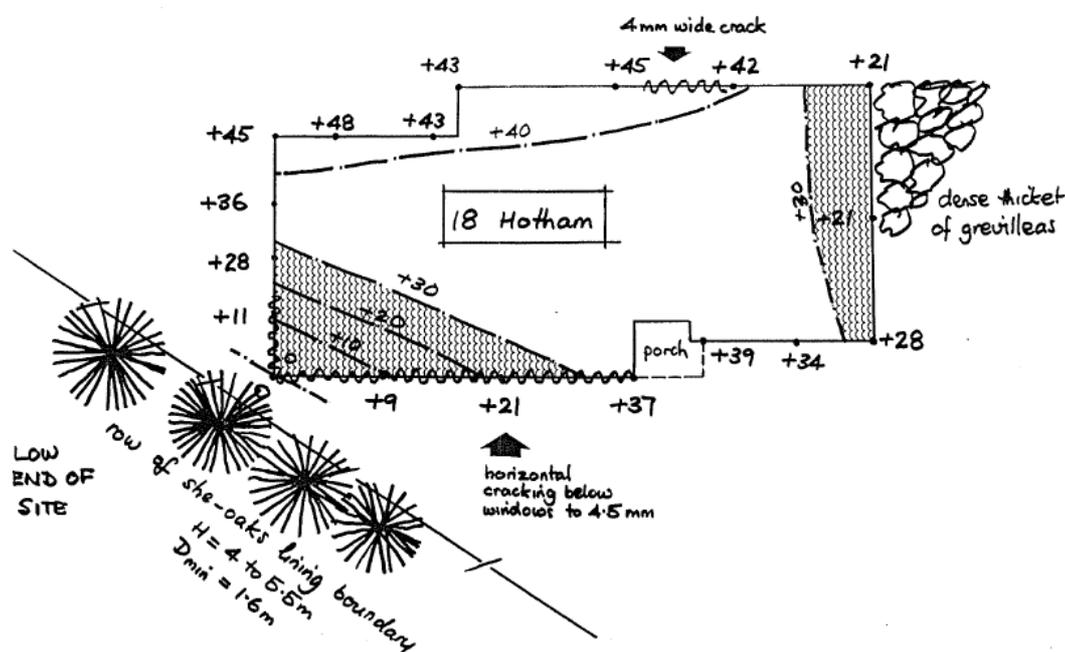
**Figure 1. Contours of relative differences in level across a concrete floor at the time of inspection. Difference in level of 48 mm. The floor appeared to have settled adjacent to vegetation.**

A level survey of the floor of a damaged building, or at floor level on external walls, can be quite telling as seen in the example in Figure 1. An arbitrary datum point was chosen at the corner of the building, close to the row of she-oaks, which was the lowest point on the floor.

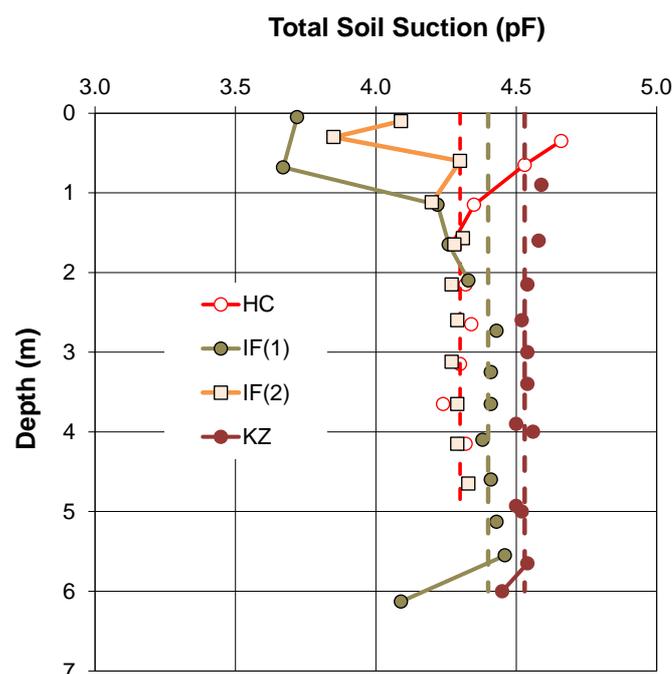
**Figure 2. Observed suction profiles near groups or rows of trees for four sites in Adelaide. The dashed lines indicate inferred values of wilting point suction, ranging between 1.9 and 3.3 MPa (4.3 and 4.53 pF). Generally the data points are shown without connecting lines except in the top 1.5 to 2 m.**

Wilting point suction,  $u_{wp}$ , was inferred by Cameron (2001) from soil suction profiles taken near trees. Examples are given in Figure 2 from four sites in Adelaide near groups of trees, largely near eucalypts. Although the suction profiles were determined at various times of the year, each suction profile became relatively uniform (almost constant suction) below a depth of 2 m or so. The value of wilting point suction was taken as the constant suction value, and it varied as indicated between 1.9 and 3.3 MPa for these four examples. Another feature of Figure 2 is the depth to which the suction was maintained. Just two of the suction profiles, IF(1) and KZ, were deep enough to show that soil suction appeared to be decreasing towards the expected value at depth, which is termed the deep equilibrium suction. The deep equilibrium suction is usually around 4 pF, or 1 MPa for sites in Adelaide. The depth at which the wilting point suction decreased was close to 6 m. For lone (single) trees, the depth of drying appeared to be closer to 4 m. These depths may surprise some people; however depths of drying in wetter climates have been reported in the UK to at least 4 m (Crilly et al 1992), and to 3 m in France (Mathon and Godefroy, 2015). Both these examples were for dense tree plantings and the depths were limited to the depths of each investigation. Parry (1992) observed significant desiccation to a depth of 6 m depth near poplars in London clay.

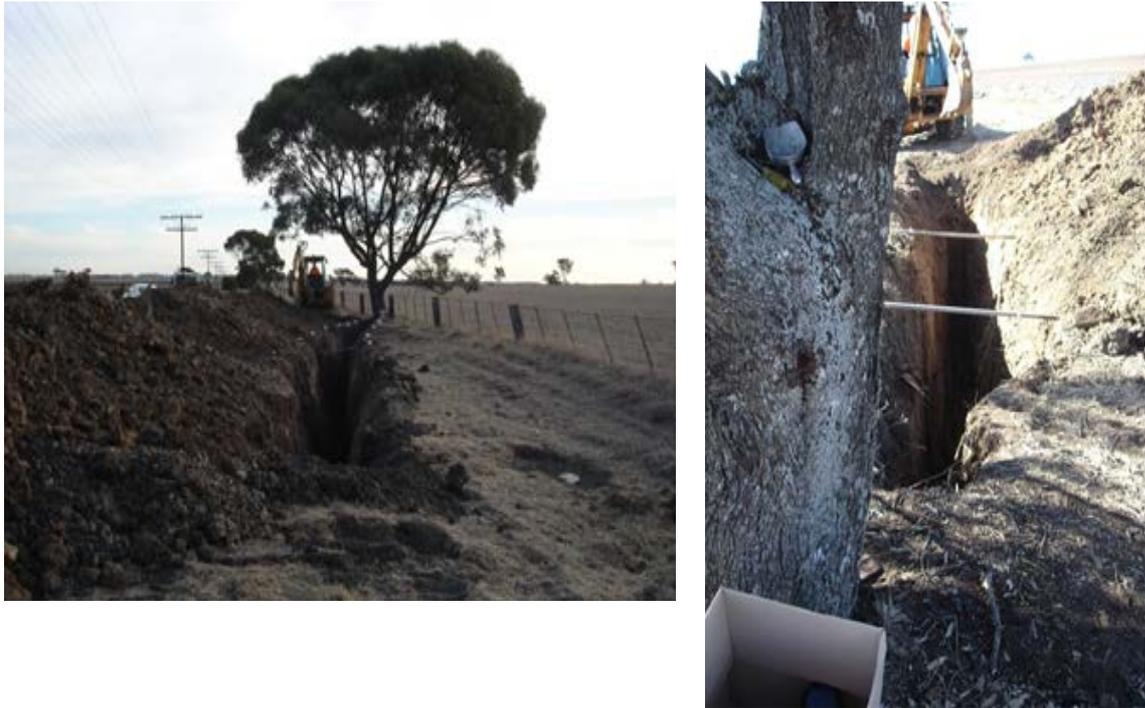
Figure 3. Photographs of trench excavation near Miram, Victoria, for Fatahi's study (2007) of root distribution

The tree was close to the Melbourne -Adelaide railway line near the town of Miram in the Mallee. Suction determinations by Fatahi suggested a depth of influence of at least 3 m and a lateral extent of 17 m, although active root density (roots 0.4 to 1.0 mm in diameter) was highest in the top 1.5 m and at a distance from the trunk of 7 to 9 m. Photographs of the excavation are provided in Figure 3.

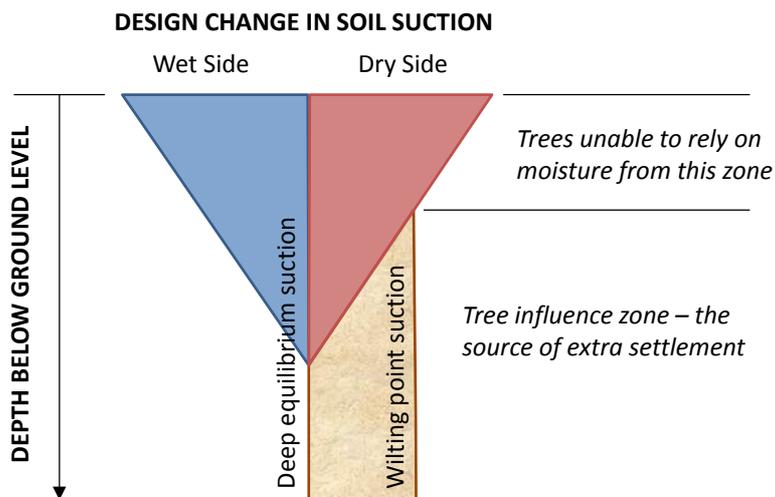
Figure 4. Idealized design suction change profiles for estimation of ground movement, with and without trees. Movement with trees is for trees close to the building ( $D/H \leq 0.5$ ).

These observations from investigations of damaged buildings (Cameron 2001) gave rise to an idealized tree influence zone for trees within a soil profile, which is illustrated in Figure 3. The red and blue triangular zones represent possible design suction changes in the absence of any trees. The depth of the tree influence zone is dependent on whether it is a single tree or a group of trees. The suction changes indicated in Figure 2 can be used by a geotechnical engineer to calculate potential ground movement for very close trees and then prepare footing designs, which will safeguard the building against serious damage.

The design suction change profiles in AS2870 are for estimation of the maximum drying settlement when the tree or trees are close ( $D/H \leq 0.5$ ). Reductions of movement can be made on the basis of relative separation distance, if the designer is satisfied that the eventual height of the tree/s can be predicted reasonably well. Who should take the responsibility of assigning tree heights is a vexed question.

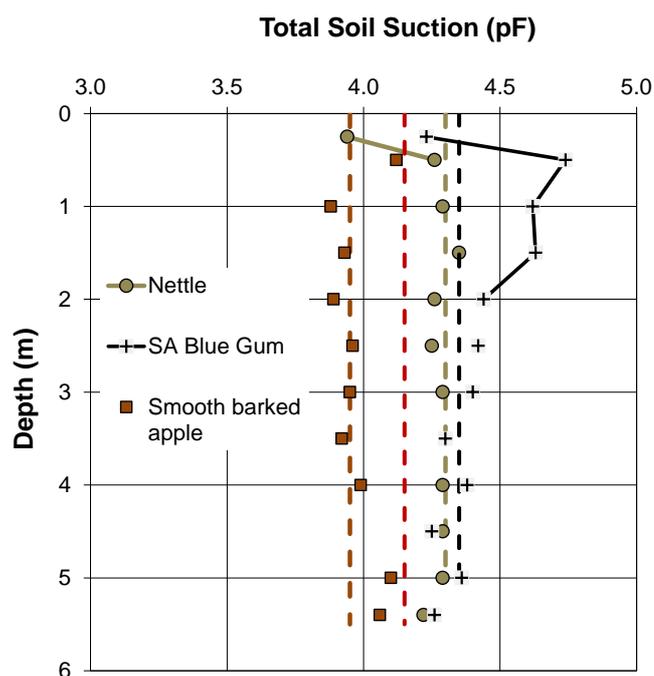
**Figure 5. Suction profiles between rows of established street trees in the City of Salisbury (2000/2001)**

At UniSA, research funded by the City of Salisbury commenced into established street trees in 2000-2001 (Cameron and O'Malley 2002). Leaf water potentials were measured regularly and soil moisture levels were checked using a neutron moisture depth probe lowered down deep access boreholes between street trees, under the pavement and away from the trees. Five species of trees were monitored. Soil suction profiles were determined usually when access tubes were constructed for neutron moisture meter access. Examples of soil suction profiles between rows of street trees are shown in Figure 5. Again it can be seen that the suction profiles below approximately 2.5 m were fairly uniform and contrasted with suction profiles taken either away from the trees or below the road. Inferred wilting point suctions for the three examples were 0.9 MPa for the smooth barked apple trees, 1.9 MPa for the nettle trees and 2.2 MPa for the South Australian blue gums. Wilting point suctions for red ironbark trees and jacarandas were 1.7 and 1.4 MPa, respectively. The range for the five species in the study was 3.95 to 4.35 pF units.

Leaf water potentials were taken in the early afternoon each month on four of the species and were not seen to vary much between species. In hindsight, daily variations of leaf water potential would have been preferable to assess the maximum daily value. The values of leaf suction taken from the four target trees varied little over the course of the year, ranging between 4.2 pF and 4.35 pF (1.5 and 2.2 MPa), which was similar generally to the variation of inferred wilting point suctions, except for the smooth barked apple tree.

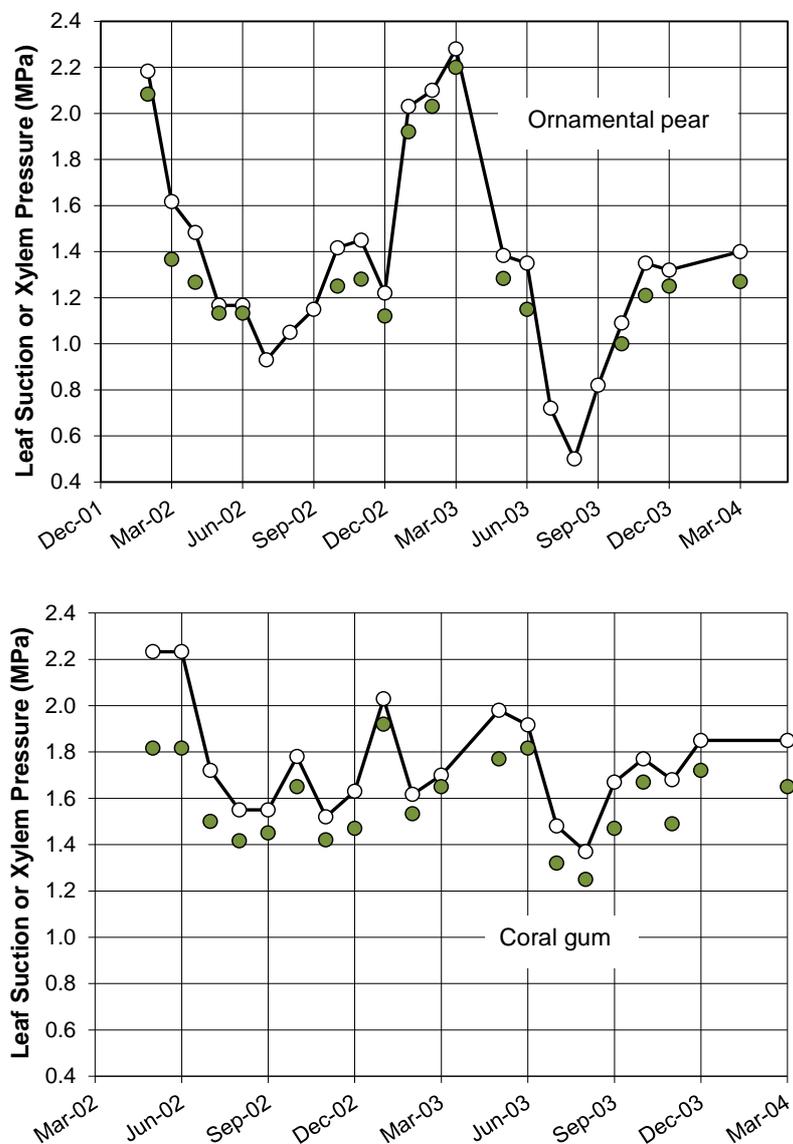
Figure 6. Leaf water potentials and xylem pressure variations with time (O'Malley, unpublished data). Leaf suction points are shown as unconnected data points, xylem pressures as connected points.

This research effort continued between 2001 and 2006 through funding from the City of Salisbury and the Local Government Association (Cameron and O'Malley 2002, O'Malley and Cameron 2005). Aaron O'Malley undertook the research project under the supervision of the author. The strategy from the previous research project continued, with leaf water potentials complemented by xylem pressure measurements (Scholander pressure bomb) on the young street trees. Xylem pressure measurements were seen to have advantages over leaf water potentials as xylem pressures can be determined on leafless trees, and the two instruments produced similar readings, as seen in Figure 6. In this Figure, data are presented for an ornamental pear and for a coral gum. The xylem pressures varied greatly between 0.5 and 2.35 MPa for the ornamental pear, and the leaf suction tracked the xylem pressures quite well when the tree was in leaf. The xylem pressures recorded for the evergreen coral gum showed less seasonal variation and values were consistently higher than the leaf suction.

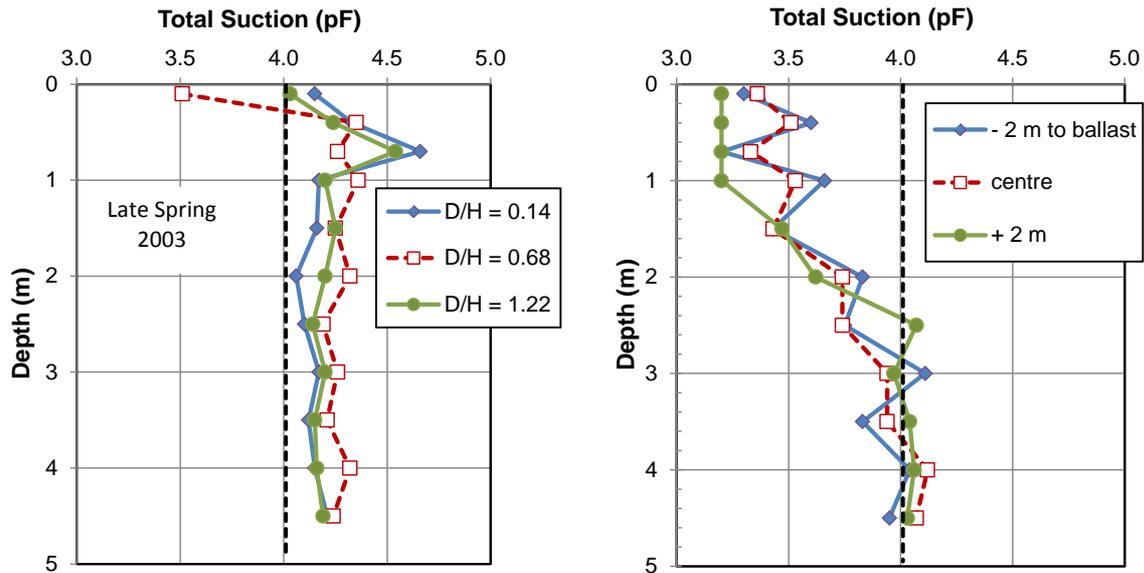
Figure 8. Soil suction profiles from the Miram site, 2 m either side of the track (ballast toe) and under the centre of the track (broken red line). The plot on the left side shows suction profiles near a row of blackbox trees, 7 m high. The plot on the right shows suction profiles at the same time at a nearby site without trees. The deep equilibrium suction was determined to be 4.0 pF, the average of 20 suction determinations at 4 and 4.5 m depths at the non-vegetated site over two sampling times. This value is depicted as a black broken line.

Examples of suction profiles from the Miram site are provided in Figure 7. At Miram, a row of blackbox trees, approximately 7 m high, were aligned in the rail corridor, just 3 m from the edge of the ballast (refer photograph in Figure 8, right hand side). The Figure confirms earlier observations about deep drying near trees; the deep equilibrium suction had not been reached at the treed site at the depth of the investigation (4.5 m). In contrast at the non-treed site, suction profiles were close to the deep equilibrium suction at depths of 3 m and greater. More importantly for the long-term performance of the rail, the top metre or so of soil had been kept dry (saturated at the corresponding non-treed site). Accordingly, the stiffness of the drier shallow soil was 3.5 to 15 times greater than the soil at the non-vegetated site.

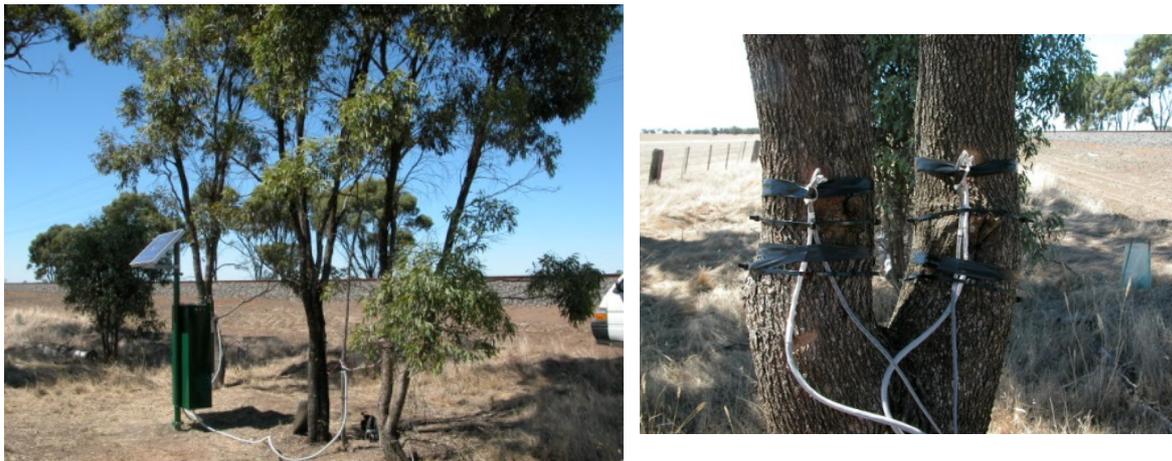
Figure 9. The Miram site and blackbox trees with sap flux instrumentation

At the Miram site, sap flux equipment developed by Steve Green of Transflo NZ was used to measure transpiration of the blackbox trees (Cameron and Mills 2006). Photographs of the site and instrumentation are presented in Figure 9. A comparison was made between the reference evapotranspiration for grass,  $ET_0$ , determined using data from an on-site weather station, and transpiration of two trunks of a tree as measured by the sap flux equipment; the plots are provided in Figure 10. The data are cumulative and indicate that in the fairly non-interrupted period between mid-winter and the start of summer, transpiration kept pace with  $ET_0$  until it accelerated in mid-summer. In addition, almost 4kL of water had been transpired, during which time, cumulative  $ET_0$  exceeded 600 mm. The ratio of transpiration to  $ET_0$  produces an apparent area of transpiring canopy of six and a half square metres.

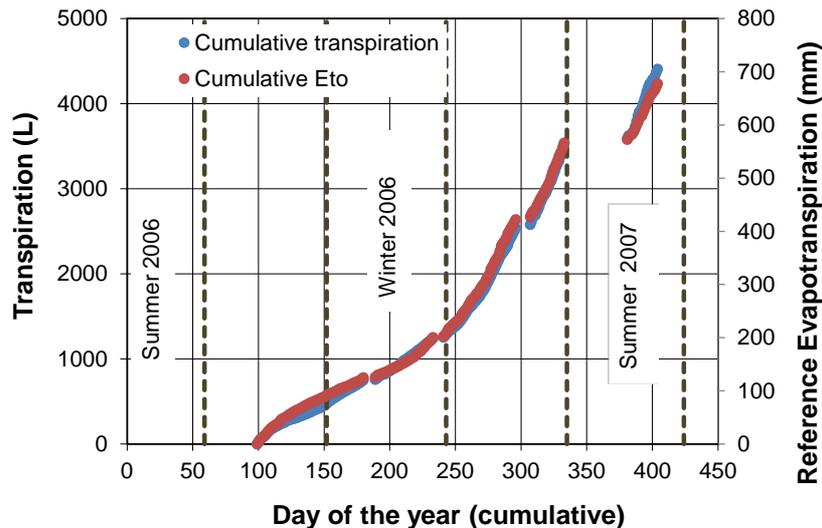
**Figure 10. Accumulation of reference evapotranspiration and transpiration of a blackbox tree with time. The broken sections indicate lost data from one of the probes or the weather station, due to a solar panel malfunction or to heat spikes in hot weather.**

As indicated by Cameron and Mills (2010), the sap flux equipment is not fool proof. The sensors and heater have to be accurately placed in the correct size drill holes. Cables need to be protected against heat spikes, and the properties of the tree need careful appraisal. Wood density and sap flux area are needed, as well as the width of the wound developed about the heater over time. Sapwood is not necessarily circular; it can be elliptical or quite irregular and so coring may not be adequate for assessing sapwood area. So although transpiration plots may look convincing, there will always be some concern over accuracy.
