The Burnside Village Tree – A Case Study of Construction and Tree Protection

Marcus Lodge
Arborman Tree Solutions

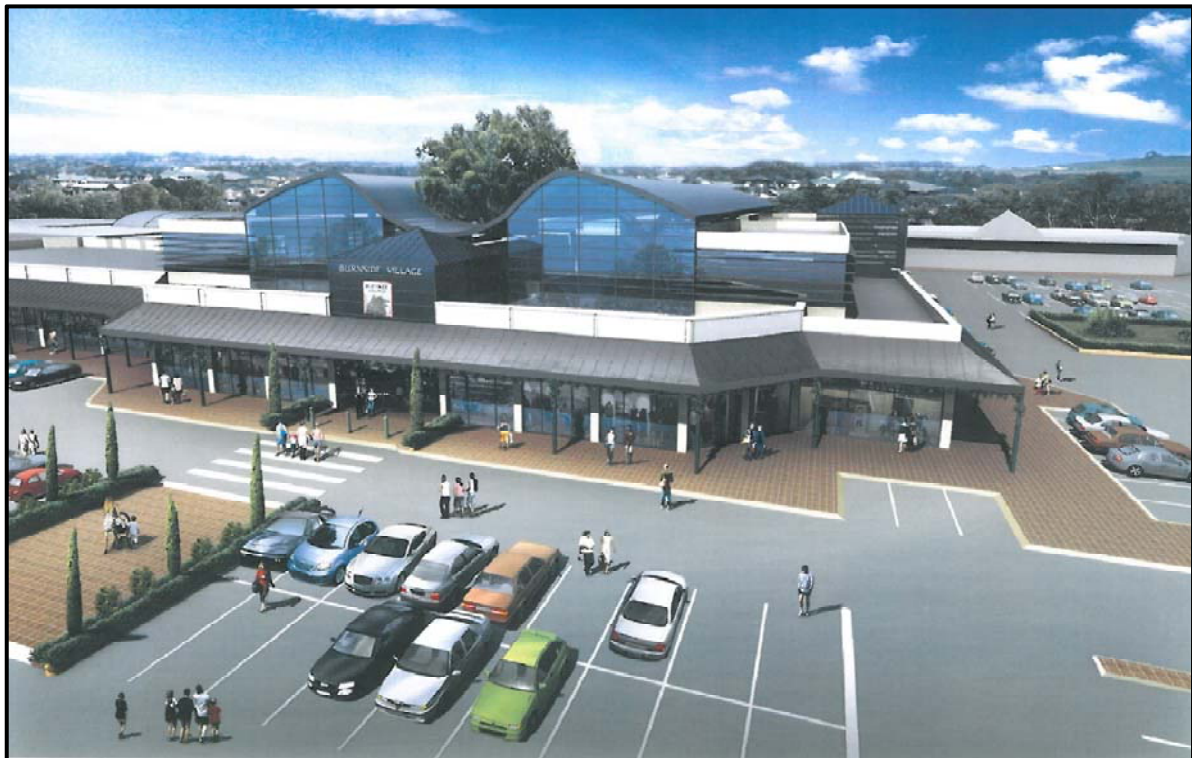
In late 2008 to early 2009 the preliminary design was put together with the tree to be centred in a new mall area with shops on three sides and the main entrance on the fourth side. The tree was to be retained in an open alfresco type area with its crown extending through and above the roof. Due to the need for increased car parking the area around the tree's TPZ was to be excavated to allow for under croft parking; effectively this was akin to putting the tree in a large pot. Whilst there were some obvious challenges these preliminary designs looked very exciting and promised a good result for both the shopping centre and the tree.
